# Cluster EFW Anomaly Report

## Problem with Probe 1 on SC3

EFW-IRFU-AR-004

27 September 2002

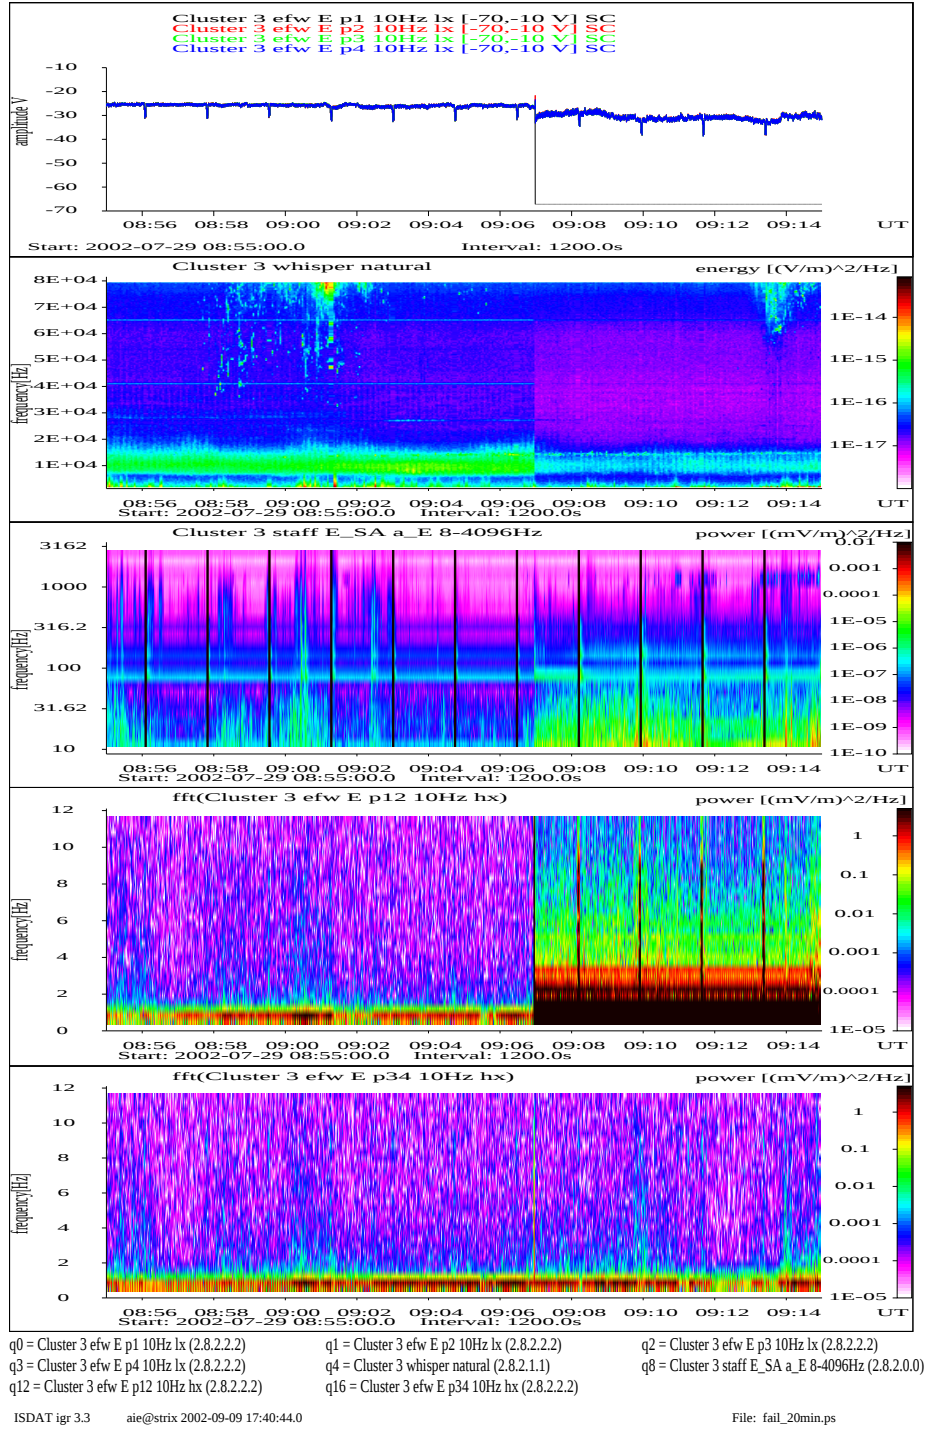
Figure 1 shows EFW, WHISPER and STAFF SA data from the time of the failure. At the time, all probes on SC1 were in electric field mode with a bias current set at -35 digital units, corresponding to -137 nA. At 09:06:59, the probe-to-spacecraft potential of P1 (black line in top panel) suddenly falls from around -23 V to -68.57 V, which is the saturation value of the A-to-D converters. Compared to Figure 1 of EFW-IRFU-AR-003, there is not as much increase in narrowband WHISPER contamination, but otherwise the two failures show the same characteristics.

Figure 1: WEC data from SC3 at the time of the P1 failure. From top to bottom: (1) EFW individual probe potentials, in order black-rgb for P1-P4. (2) WHISPER natural mode spectra. (3) STAFF SA electric spectra. (4, 5) Spectra of EFW E12 and E34, respectively.

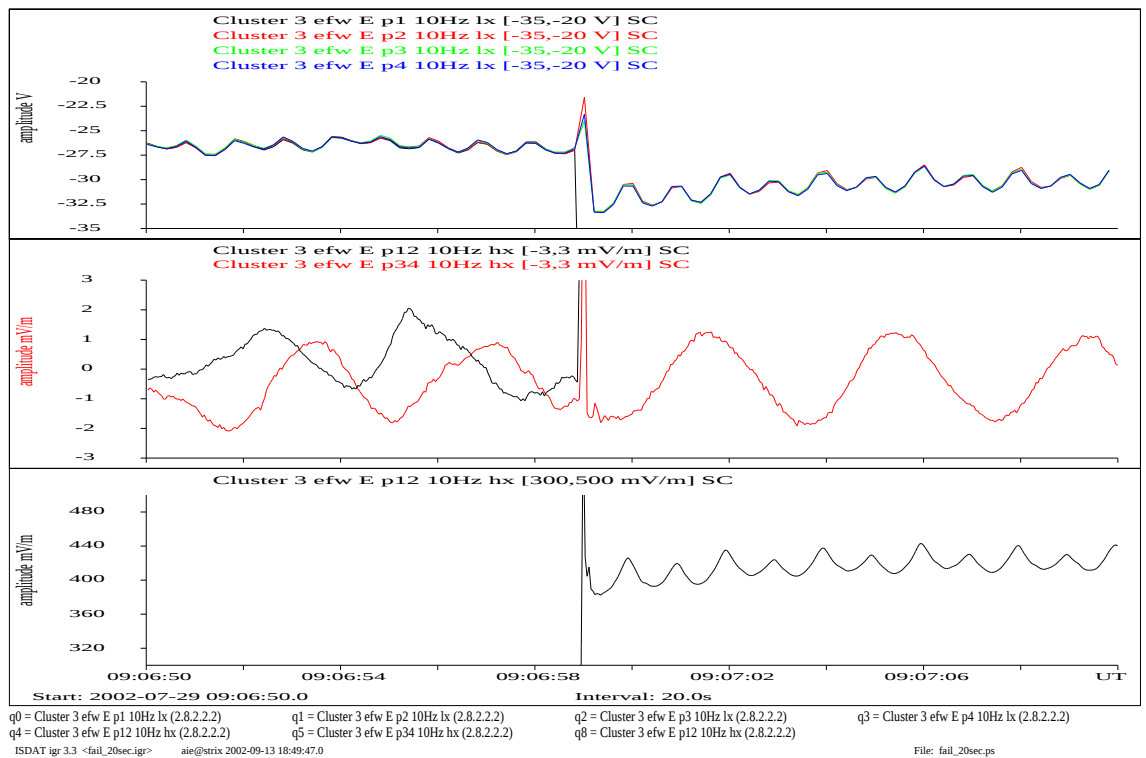
In Figure 2, we see a blowup of the 20 seconds around the failure time. Most characteristics are consistent with Figure 2 of EFW-IRFU-AR-003. The probe potentials (top panel) can be seen to change from about -27 V before the failure to -32 V after an initial overshoot. As P1 now is at maximum negative bias current, it emits more photoelectrons than before, so the spacecraft potential must adjust itself accordingly, which explains the change. The central panel shows the two spinning E-field components E12 and E34. After some initial excursions, E34 reassumes its sinusoidal pattern. E12 of course changes drastically, with the new value of around 0.4 V/m essentially

being the difference of the P1 and P2 probe potentials,  $68 - 32 \text{ V} = 36 \text{ V}$ , divided by the 88 m probe separation. The increased level of variation simply is the variation of the spacecraft potential that can be seen in the top panel divided by the 88 m, which we should expect to see as V1 is stuck at -68 V while V2 varies with the satellite potential.

Figure 2: SC3 EFW data at the time of P1 failure. From top to bottom: (1) individual probe potentials, in order black-rgb for P1-P4. (2) E12 and E34. (3) E34 (shifted plot).

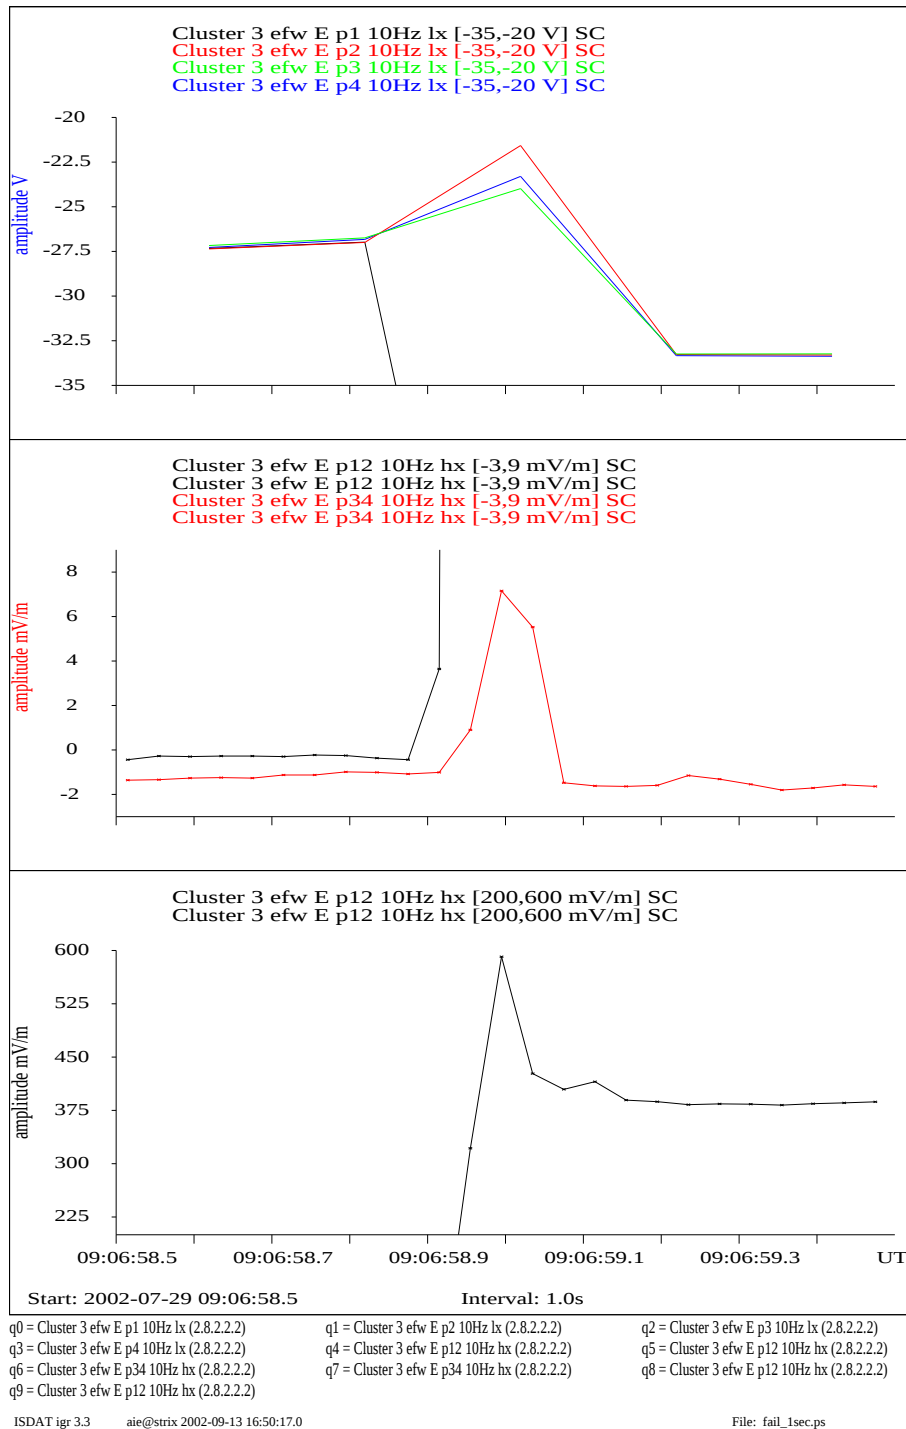
The similarity to the failure of P1 on SC1 is retained in the one-second plots in Figure 3. The individual probe potentials are sampled at a rate of 5 per second, while E12 and E34 are sampled 25 times per second. All data are low-pass filtered at 10 Hz, so there is a time constant of about 0.1 s associated with the filters. E12 reaches its peak value in about this time, while V1 immediately goes down to -68 V (sample not shown), without signs of any time constant. This can be the case because the V1 data are undersampled (filtered at 10 Hz, sampled at 5 per second).

Figure 3: SC3 detailed EFW data at the time of P1 failure. Format as in Figure 2.

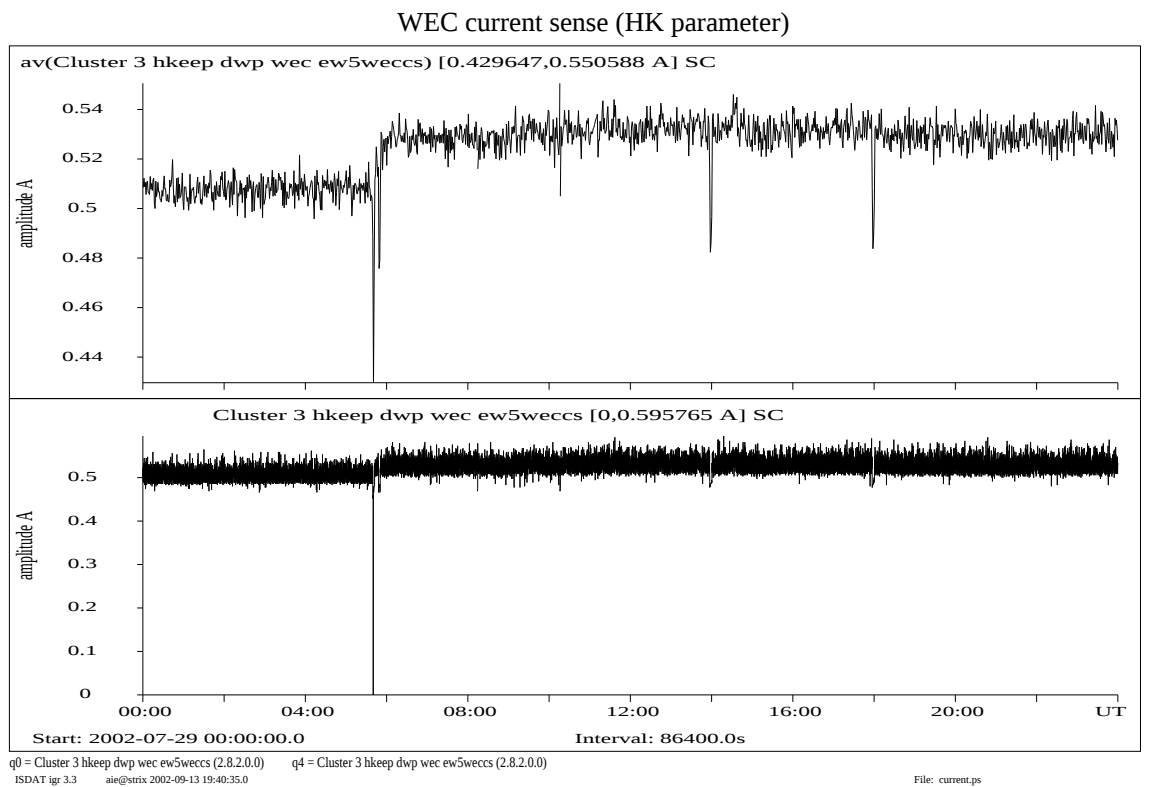
In addition to these science data, the EFW digital subcom telemetry (DSC, time resolution 32 s) carries some additional information. As in the case of SC1, there is no change in the set bias value on P1; nor is there any change of the value of the bias current measured onboard. The total current to WEC, plotted in Figure 4 for all the day, does not show any clear signature at the time of the failure either.

Figure 4: SC3 WEC current for the day of the P1 failure. Top panel is one minute averages, bottom is full HK time resolution (5.1 s).

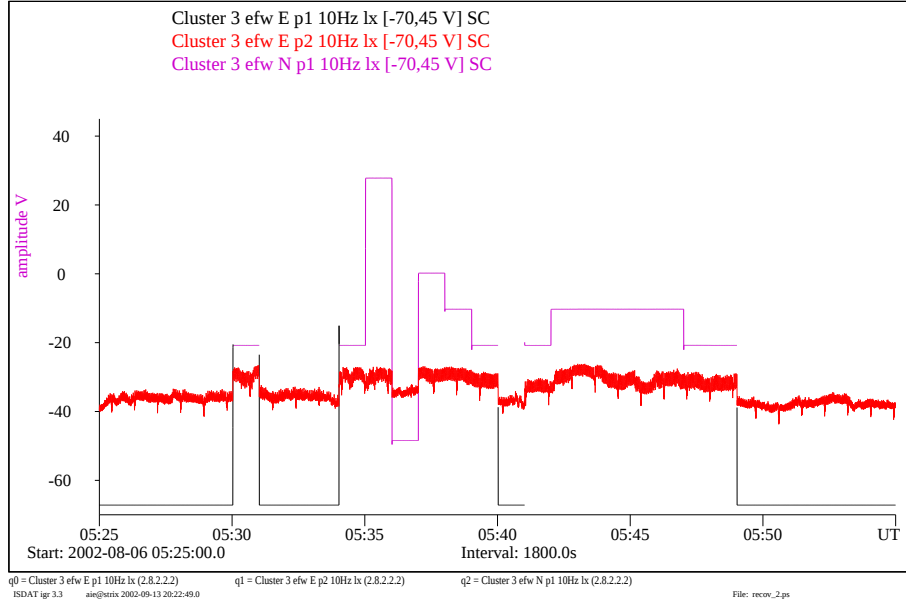
Figure 5: SC3 EFW P1 and P2 data during the recovery attempt and diagnostic test. Red is P2; black/magenta is P1 when in E-field/density mode.

An overview of the probe data from the test is seen in Figure 5. Red is probe 2, which stayed in current bias mode (E-field) during the test. Black is P1 when in E-field mode, magenta is P1 when in bias voltage (density) mode. The voltage bias test data are summarized in Table 2. A slight response of the probe potential to the puck voltage change at 05:43 can be seen in the detailed plot in Figure 6.

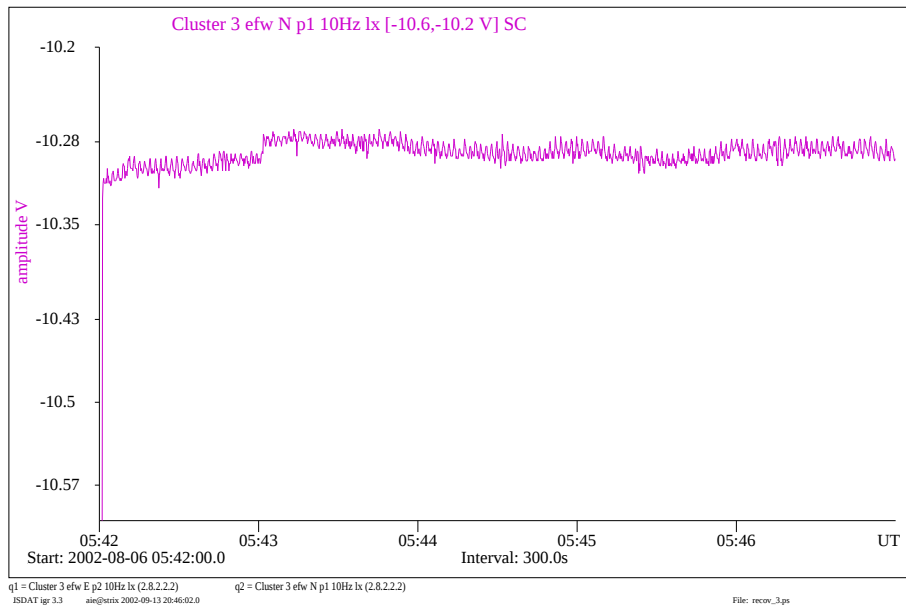
Figure 6: Detail of the SC3 EFW P1 data during the diagnostic test. The probe is in bias voltage mode. There is a small effect of the puck voltage setting to +1.25 V at 05:43, and an even smaller of its setting to -1.25 V at 05:45.

As in the case of P1 on SC1, the result points to a failure of the 12 V power to the preamplifier in the puck. Such a failure would have immediate impact on the feedback to the bias circuitry, so that the probe gets stuck at maximum negative bias as is observed, and also give the observed difference between set and measured potential when in Langmuir mode. The small cross-talk observed when changing the puck potential is also consistent with this interpretation.
